**THE TRIBOLOGICAL BEHAVIOUR OF A HIGH NITROGEN
MANGANESE AUSTENITIC STAINLESS STEEL**

BY DUNCAN JOHN MILLS

A Thesis submitted to the Faculty of Engineering, University of Cape Town in
fulfilment of the degree of Master of Science in Applied Science.

Department of Materials Engineering

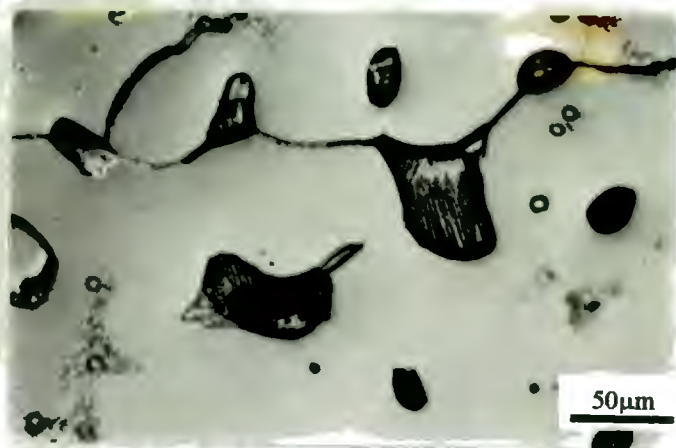
Figure 5.14: 811 after 4 hours at 700°C. The cellular precipitate is threatening to fill entire ferrite grains.

Figure 5.14: 811 after 4 hours at 700°C. The cellular precipitate is threatening to fill entire ferrite grains.

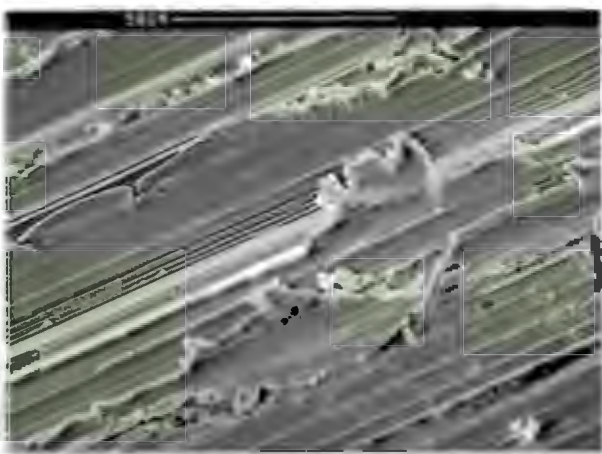
Figure 5.33: The wear surface of 811 aged at 700°C for ½ an hour. There is very little difference in the appearance compared with the previous micrograph. This micrograph shows the shear lips being removed from the bulk material.

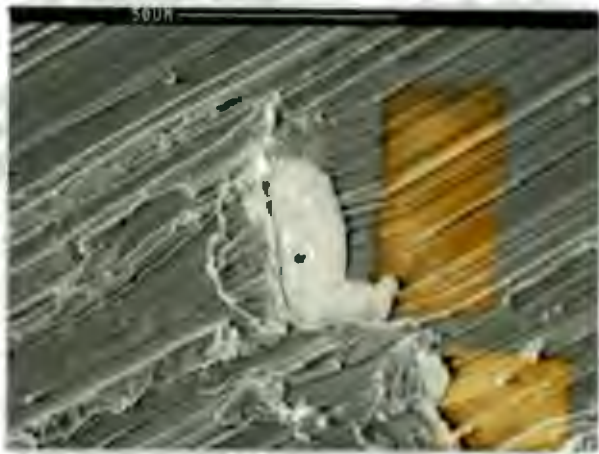
Figure 5.34: The wear surface of 811 aged at 700°C for 2 hours. Again, there is little difference in the wear surface. This micrograph shows the embedding of an abrasive particle.

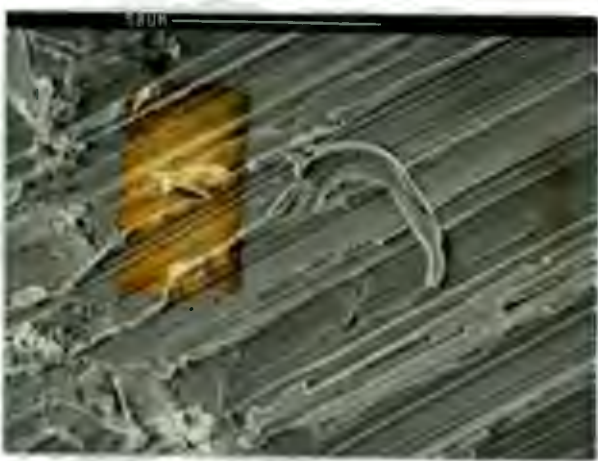
Figure 5.35: The wear surface of 811 aged at 700°C for 8 hours. This micrograph shows the removal of a shear lip.

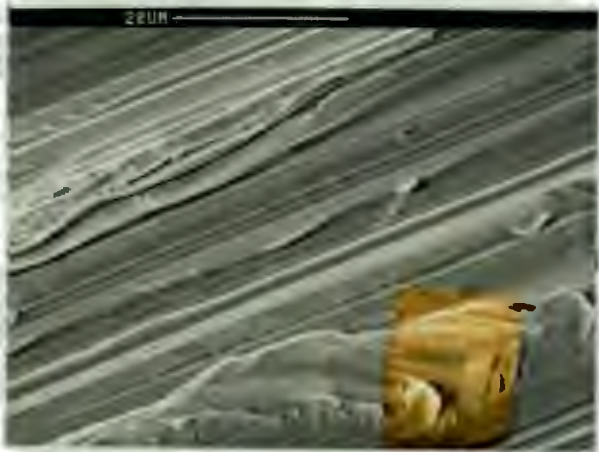
Figure 5.36: The wear surface of 811 aged at 900°C for ½ an hour. This micrograph presents a good example of the work hardened shear lips.

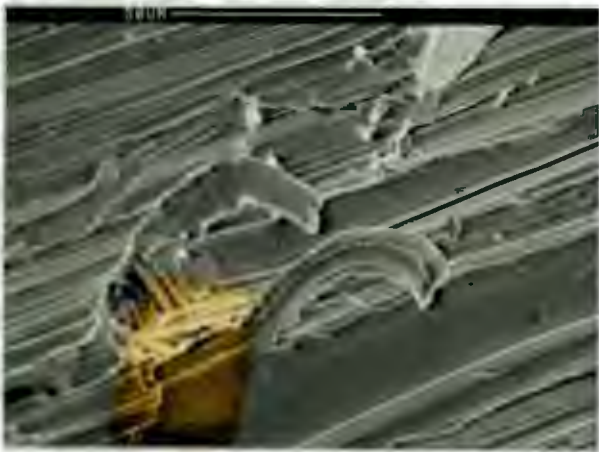
Figure 5.37: The wear surface of 811 aged at 900°C for 2 hours. Work hardened lips of material being removed from the surface.

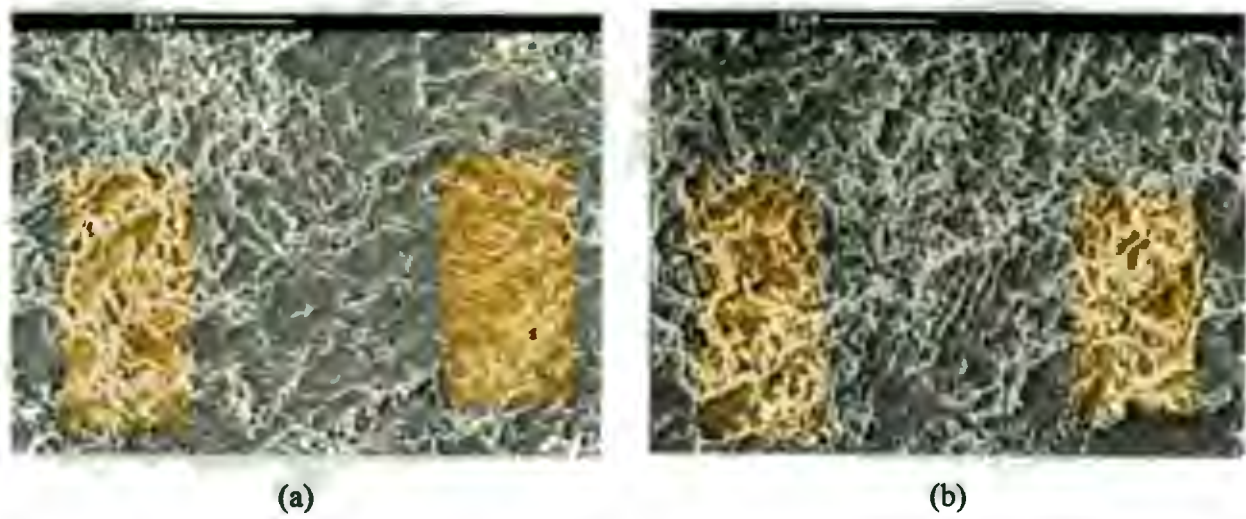
Figure 5.47: The cavitation eroded surface of AISI 316 after 12 hours showing the formation of slip lines, (a), and the dimpling effect and removal of material, (b).

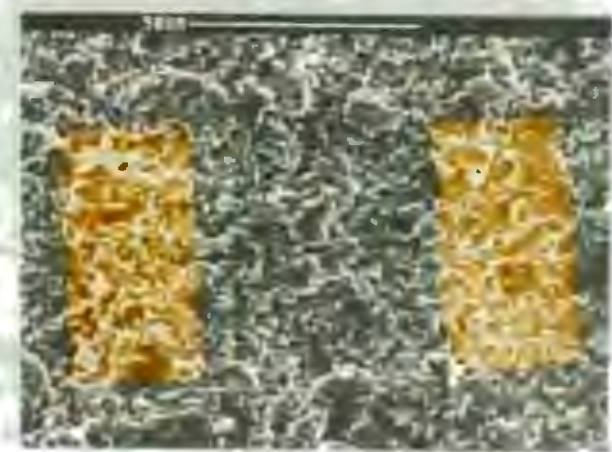
Figure 5.48: The cavitation eroded surface of 852 after 12 hours of cavitation erosion. There is evidence of small cracks propagating between the dimples. The joining of these cracks cause material loss.

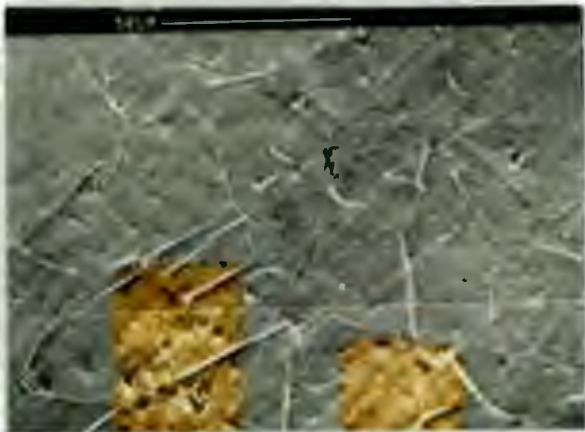
Figure 5.51: After the annealed 852 has been cavitated for ½ an hour the grain boundaries are raised further.

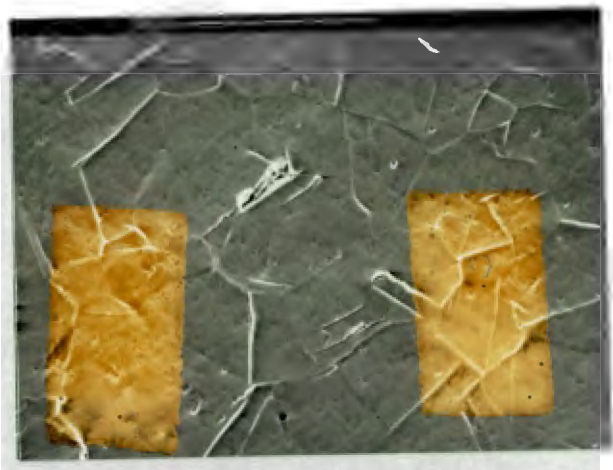
Figure 5.53: Annealed 852 cavitated for 1½ hours has larger pieces of material removed from the grain boundaries.

After 90 minutes of cavitation erosion all the grain boundaries are raised and there is material loss from most of the grain boundaries. This stage is shown in figure 6.4. This material loss is due to fatigue. The cavitation process, as detailed in the schematics above, causes the grain boundaries to be raised. The imploding bubbles results in stress waves or jets of liquid with most of the stress being directed parallel to the surface. The raised grain boundaries are then subjected to a greater force than the flat surface. The removal of the raised grain boundary material is then caused by a fatigue process. The cyclic stresses which cause the fatigue are due to the cyclic implosion of bubbles. The fatigue process proceeds according to that outlined by Suresh²⁶ and is shown in section 3.3.3. The first step would be the creation of irreversible changes in the microstructure. In the case of cavitation erosion this would be the slip of dislocations. The second step is the formation of macroscopic defects (cracks) and these are evident on the SEM micrographs of cavitated material. This is followed by the subcritical growth of these cracks by the repetitive stress from the cavitation process. The fact that these cracks are growing subcritically is evident from the striations (or clam shell marks) on the surface. These marks are imaged on some of the SEM micrographs (Figure 5.55, Figure 5.60 and Figure 5.70). The exposed ferrite areas continue to be eroded at a greater rate than the austenite areas.

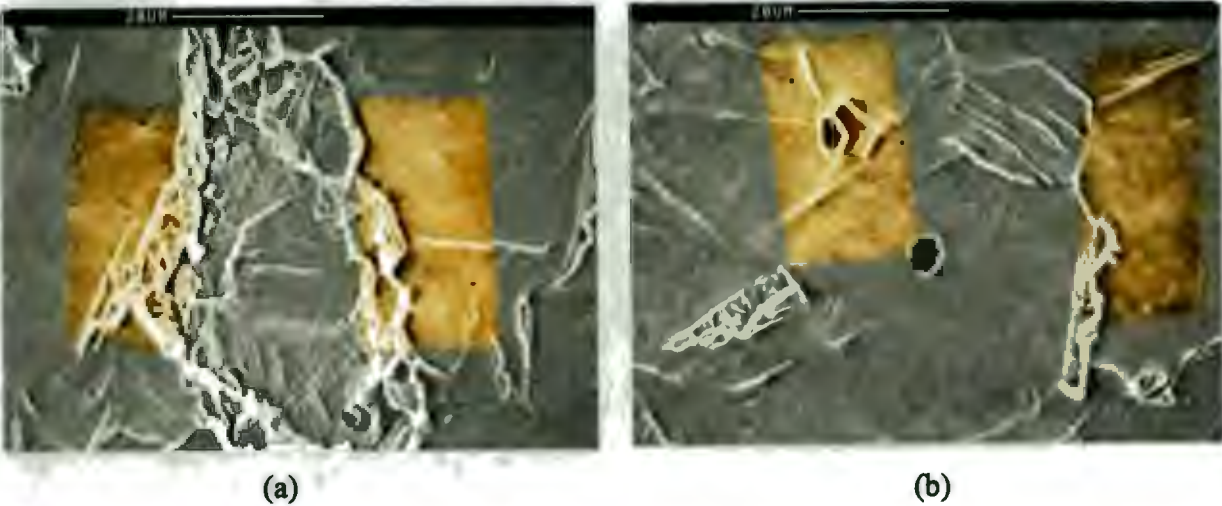
Figure 5.55: Annealed 852 cavitated for 3 hours, (a) shows the process of fatigue whereby the material is removed from the grain boundaries. The fatigue striations can be seen where the material has been removed. Micrograph (b) shows slip and grain boundary material removal.

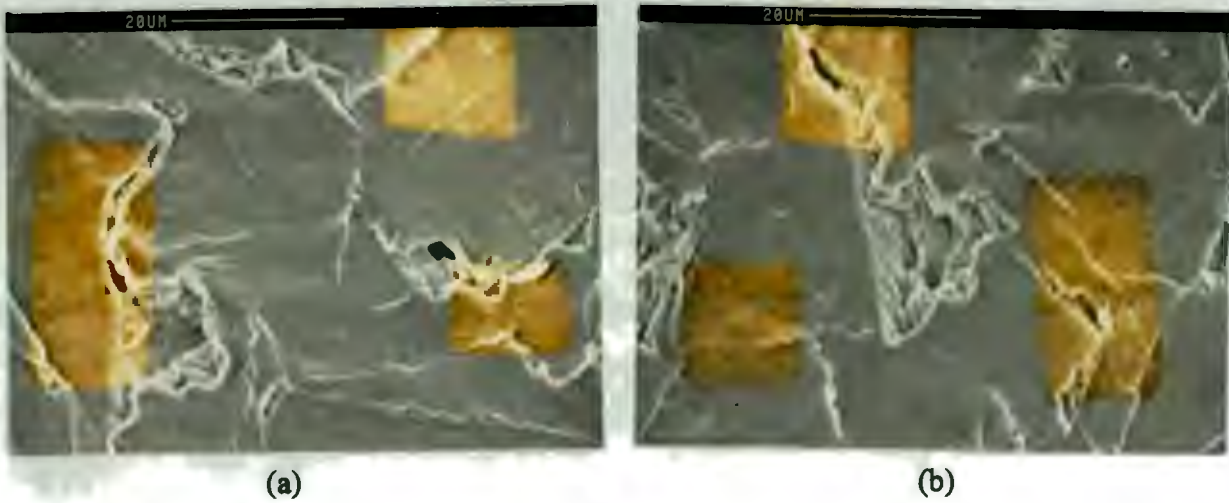
Figure 5.56: Annealed 852 cavitated for 4 hours has further large scale removal of material from the grain boundaries (a), and the removal of material to a smaller extent from the slip lines within the grains (b).

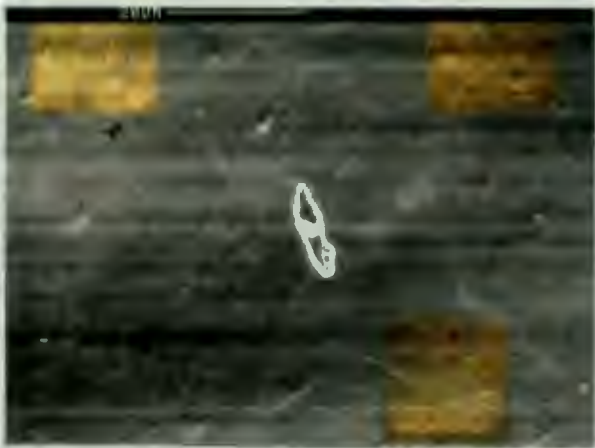
Figure 5.58: 852 with 16% cold reduction and cavitated for 0.5 hours, there is the removal of some of the harder ferrite phase but no other material is eroded or displaced.

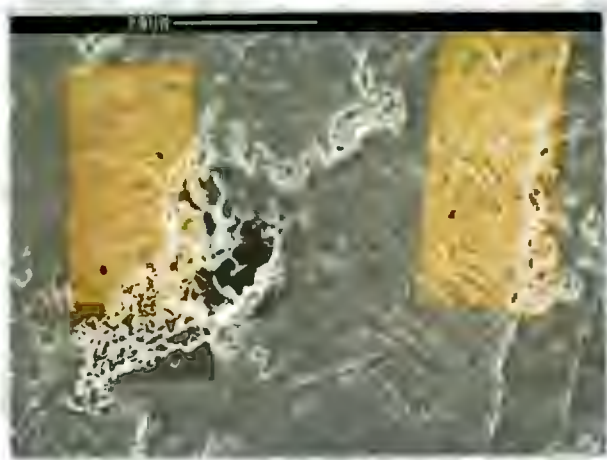
Figure 5.64: 852 with 16% cold reduction and cavitated for 5 hours. The ferrite areas are eroded and there is severe slip within the grains. There is material loss from the grain boundaries.

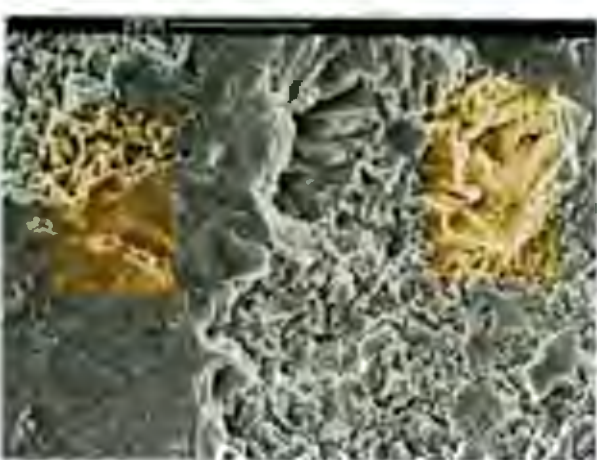
Figure 5.65: 852 with 16% cold reduction and cavitated for 6 hours. The onset of the steady state, as evidenced by large scale dimpling and an irregular surface.
